Preservation Plan and Design Guidelines for Brumby Hall

Prepared by Erin Parr
For the Marietta Historic Preservation Commission
July 15, 2009
Revised October 23, 2009

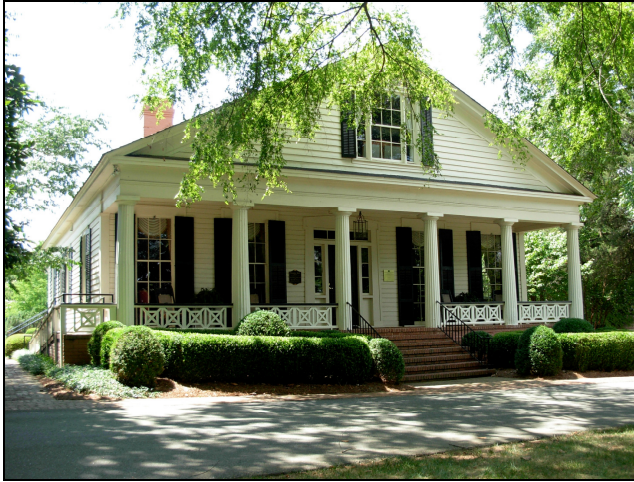
East Façade

The east façade is considered the front of the house and features all the details of the Greek Revival architectural style. This façade has a full entry porch topped with a prominent forward facing gable and supported with six fluted Doric columns. Between each column is a balustrade with an X-and-box design. The front door is centered on the façade with two full-length windows on either side. The door, made of wood with a simple and symmetrical panel design, is not original. The door surround is Egyptian in style and features a four-light transom above the door and three-light sidelights on either side. The full-length wood windows on either side of the door are double-hung and feature a six-over-nine light configuration and functioning shutters. The gable has one six-over-six double-hung wood window with four-light sidelights on either side. A vent can be seen between the top of the window and the roof. A centered brick stair with iron railing leads to the porch. The porch floor is made of brick laid in a herringbone pattern.

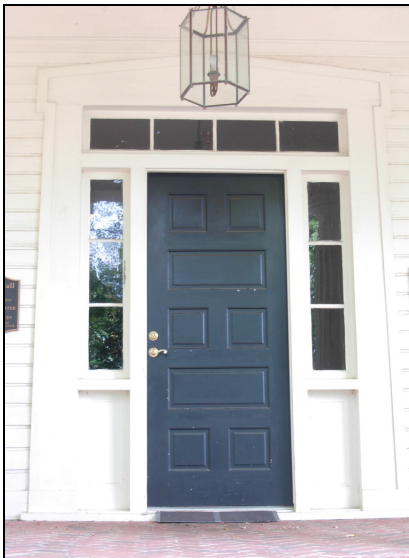
Front Door – East Façade

- Historic doors are in good condition and should be retained and repaired.
- Caulking and weatherstripping can be done to improve energy efficiency.
- Decorative moulding and transoms/sidelights around doors should be retained and not obscured.

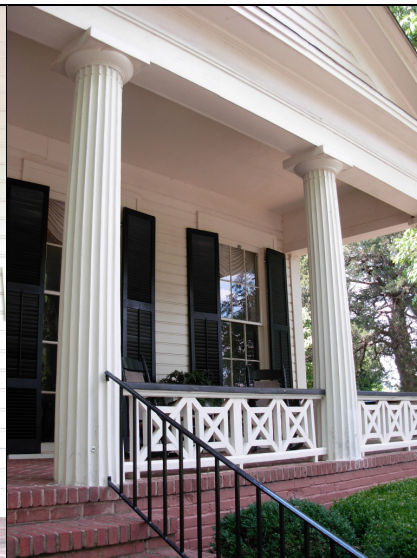
Porch Columns – East Façade

- Porch materials and decorative elements are in good condition and should be retained. The glass enclosing back (west) porch can be removed in order to restore it back to original appearance.
- Original materials should be maintained and preserved. If replacement becomes necessary, in kind materials should be used.
- Porches should not be removed.
- Routine inspection and maintenance should be performed on the six columns on the front (east) porch. These columns are vital to the building's character and architectural style. These columns should not be removed and only replaced in cases of extreme deterioration.

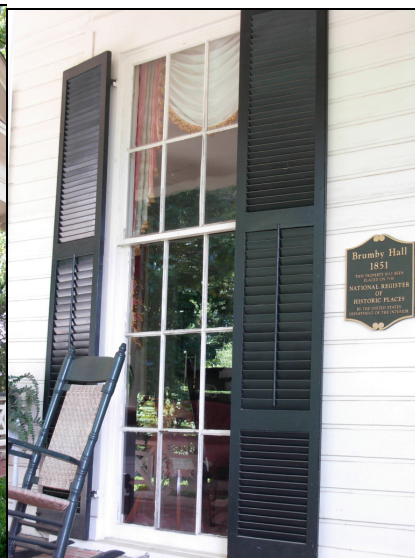
Floor to Ceiling Windows – East

- Historic windows are in good condition and should be retained and repaired.
- Caulking and weatherstripping can be done to improve energy efficiency.
- Interior and exterior storm windows can be installed where feasible. These should match the window in size and proportion and not detract or damage the historic window.
- Functioning shutters should be retained and repaired. If replacement is necessary due to extensive deterioration, shutters should be replaced in like, kind and quality.
- Decorative moulding and sidelights around windows should be retained and not obscured.

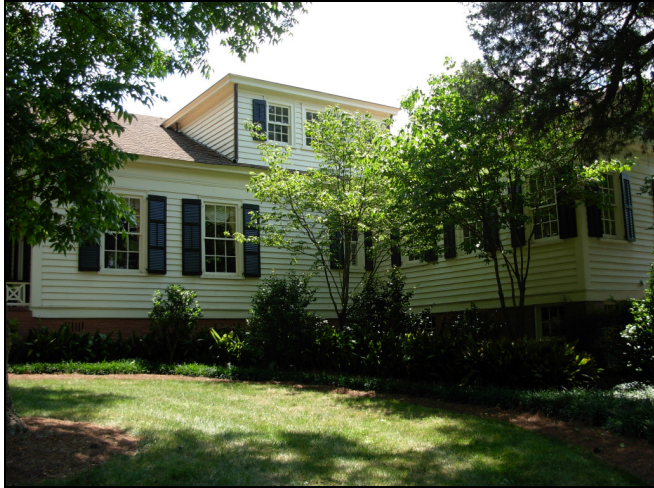
North Façade with Kitchen Addition (Right)

The north façade bears the 1920s kitchen and roof additions. All the windows on this façade are made of wood and are double-hung with a six-over-six light configuration unless otherwise noted. The original section of the house has two standard size windows, a smaller four-over-four window near the kitchen addition, and a four-light fixed window at the basement level. The east façade of the kitchen addition has three windows on the main level and three six-light fixed windows at the basement level. The north façade of the kitchen addition has two windows at the main level and two at the basement level. The roof addition features three windows.

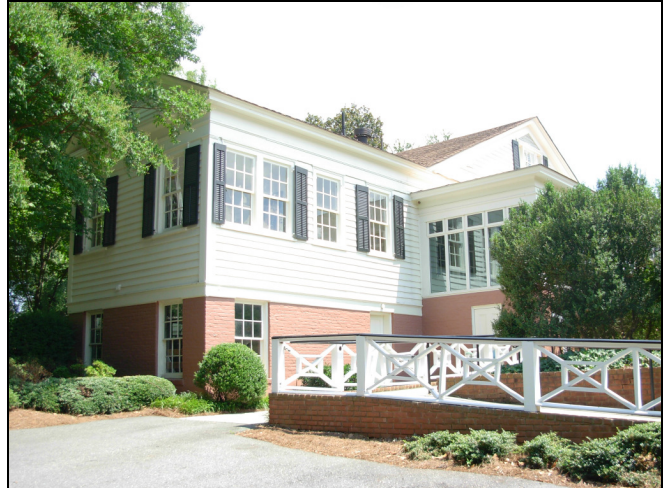
West Façade – Kitchen Addition and Handicap Ramp

The west façade features the remaining façade of the kitchen addition and the glassed in back porch. The west façade of the kitchen addition has one paired and two single wood six-over-six double-hung windows on the main level. At the basement level there is one six-over-six double-hung window and a wood two-panel door that leads into the basement. Since the porch extends from the house, there is another wood two-panel door near the kitchen addition that leads under the porch. The west porch was glassed-in in the late 1950s to early 1960s. The porch's six squared columns support its flat roof. Between each column are four sets of glass windows; a long fixed bottom window topped with a small awning window. At the center is a brick stair with modern metal railings that leads to the glass double door entry with the window set on either side. The rear gable features a wood six-over-six double-hung window with sidelights that matches the east gable's window exactly.

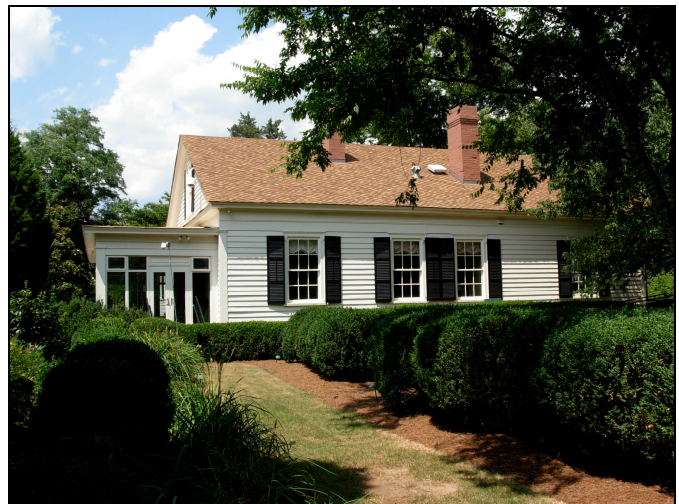
South Façade

The south façade has an additional double glass door entry to the west porch with brick stair and modern metal railing leading to it. The main portion of the house has four six-over-six double-hung wood windows with functioning shutters. Two off center brick chimneys that are painted red can be seen within the south roof surface. A modern handicap ramp is located on this side of the house and leads to the east porch. It is made of brick and features the same balustrade found on the east porch.
